Tuzla – Podisor Pipeline Site Visit Report

3. Site Visit Findings

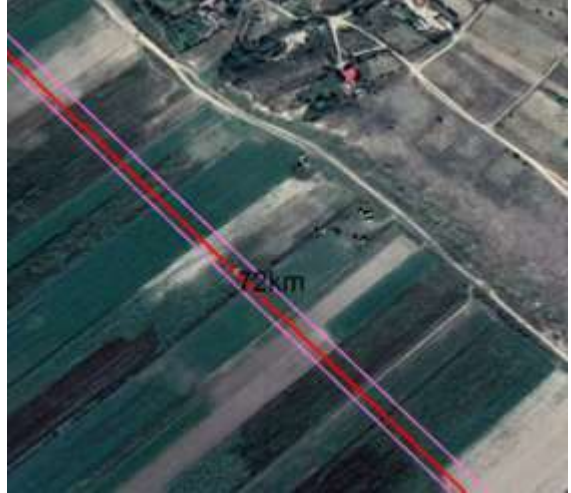
72		<p>Structures situated nearby the pipeline’s work corridor:</p> <ul style="list-style-type: none"> • No structures were identified on the ground • The work corridor is situated nearby a parking site for vehicles for agriculture

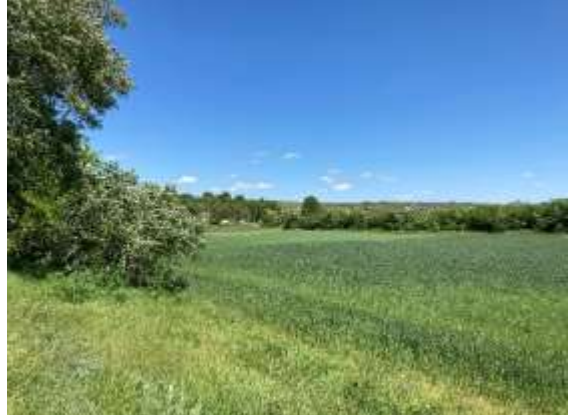
74

<p>Danube crossing – right bank of the river – HDD entry point:</p> <ul style="list-style-type: none"> • HDD work area is located on agricultural lands nearby a village – approximately 250 m away from nearby households • No access road to HDD work site • HDD site is outside the protected area, the most important biodiversity issue is the population of amphibians that can be affected by impact with work vehicles and by artificial traps formed during the works. • Access roads used for transportation of equipment and machinery necessary for HDD is not yet decided, but the national road crossing the village nearby is in good condition

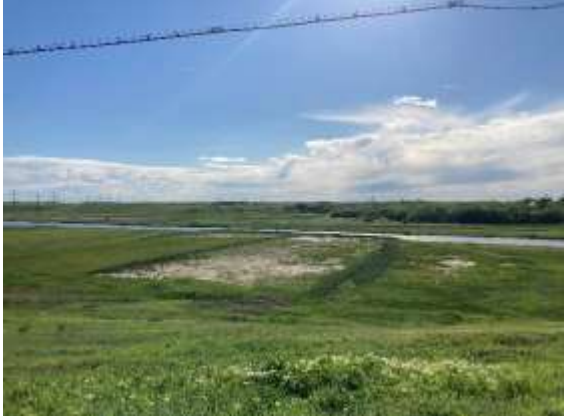
175 - 176

<p>Mostistei valley:</p> <ul style="list-style-type: none"> • A farm is located close by km. 175 • The crossing is situated close to Frasinet village. • The area is used by recreational fishermen • Construction corridor is situated close to an informal sport field • An animal farm is situated nearby as well • Natural protected area. The transit of the wetland with specific vegetation is recommended to be done following a careful monitoring of the presence of nesting species and the activity of reptile and amphibian species. For <i>Lutra lutra</i>, knowing the territory of a couple could stretch for several kilometers of waterfronts, cannot be a special problem. • Wetland

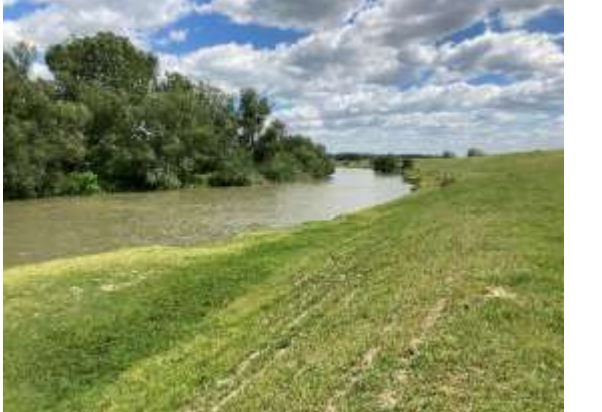
<p>HDD crossing of the Arges river:</p> <ul style="list-style-type: none"> • HDD situated on nearby farm land • The Arges river is protected by embankments on both sides, thus reducing the flooding risk in the area • In points of this type it is recommended to monitor the avifauna activity, small mammals, reptiles and amphibians activity in the site organization area.
225

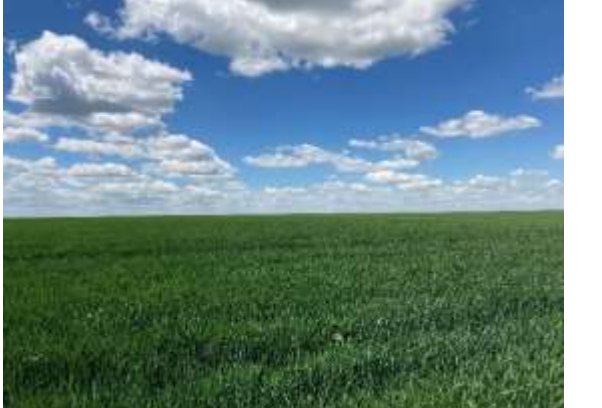
<p>Pipeline laydown area:</p> <ul style="list-style-type: none"> • Pipeline laydown area situated close to Zboiu village • The access road is an agriculture dust road • The access roads to construction corridor and the pipeline laydown areas are not yet determined • The pipeline laydown sites are already established and these areas should not suffer any modification • There are no specific issues in terms of biodiversity.

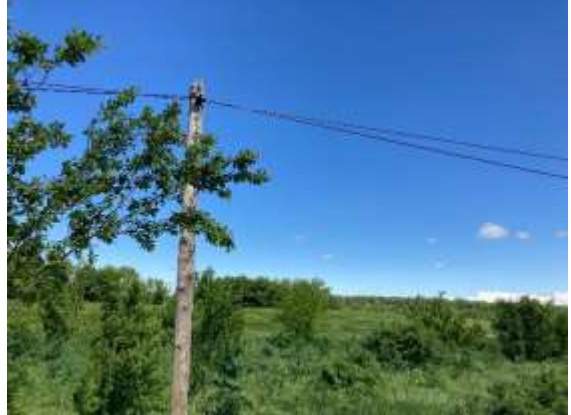
<p>Farm located close to construction corridor:</p> <ul style="list-style-type: none"> • The farm is located in the proximity of the construction corridor but the nearest structured looks deteriorated. It might be that the farm is no longer operational or has reduced its operation considerable. Further investigations are needed in order to understand the impacts of the construction / operation of the pipeline on this farm • No potential presence of rare plant species or mammalian traces that live mainly in the soil that could be disturbed by the project
308

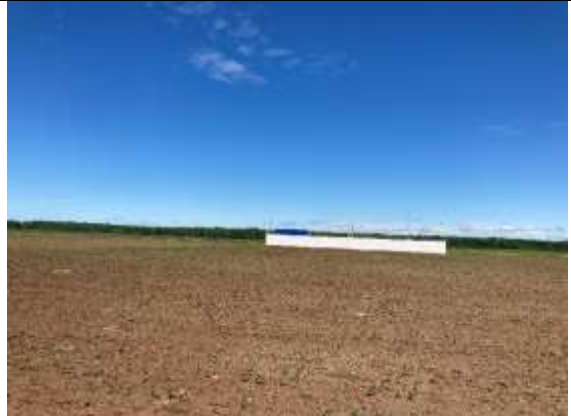
<p>Connection point to Podisor station:</p> <ul style="list-style-type: none"> • No particular aspect noticed. • The pipeline will under-cross BRUA pipeline and will access the station
